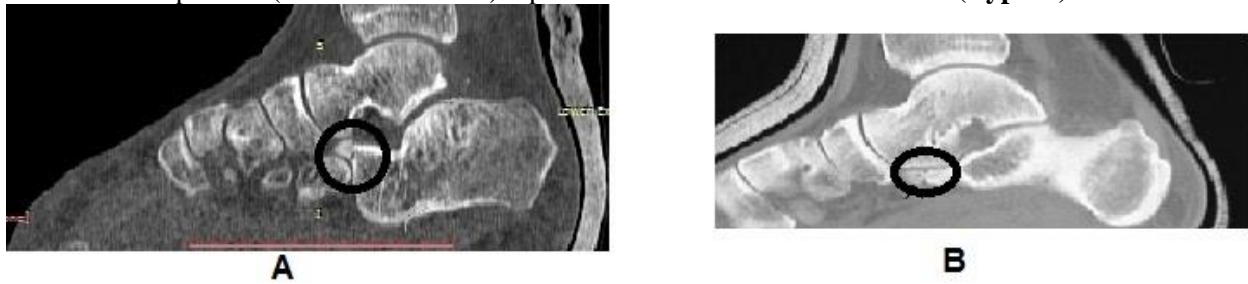
Figure (4):

Two different traumatic cases with MDCT sagittal MPR image showed fracture of anterior calcaneal process (encircled in black) represented **extra-calcaneal fracture (Type A)**.

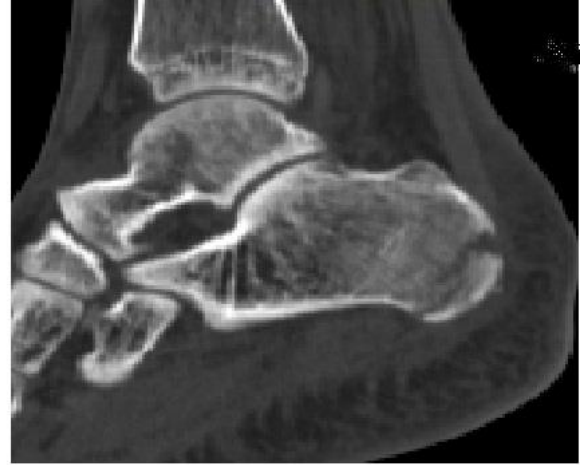
Figure (6):

Traumatic case showed **posterior calcaneal tuberosity fracture (Type C)** in MDCT coronal MPR image (A), sagittal MPR image (B) and axial image.
